Project NY 450 030  
Technical Memorandum M-109

THE ROLE OF *Limnoria tripunctata* IN PROMOTING  
EARLY FAILURE OF CREOSOTED PILING

6 April 1956

U. S. Naval Civil Engineering Research and Evaluation Laboratory  
Port Hueneme, California

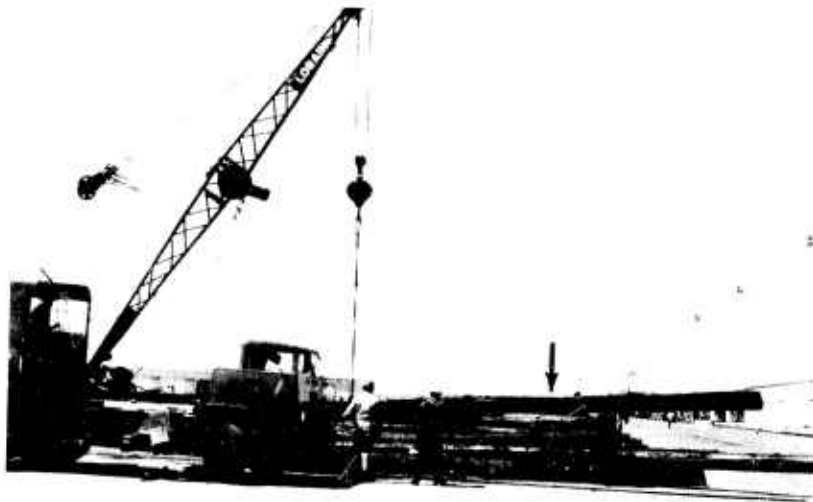
Figure 1. Equipment employed in removing old piling from the harbor.

The first row of piles was examined as it was pulled from the water. Figure 1 shows the equipment used for pulling the piles. At the position designated by the arrow in Figure 1 the pile being suspended by the crane is beginning to assume an hourglass shape. This is typical of piles damaged by *Limnoria*. Figure 2 shows the inspection team at work. Several of the connecting or bracing members were completely destroyed, as is the one shown in Figure 3. Several of the piles had deteriorated to the extent that they were nonfunctioning but most of them still were in fair condition. As will be discussed later in this report, in the ensuing years the piling would have deteriorated at a greatly accelerated rate.

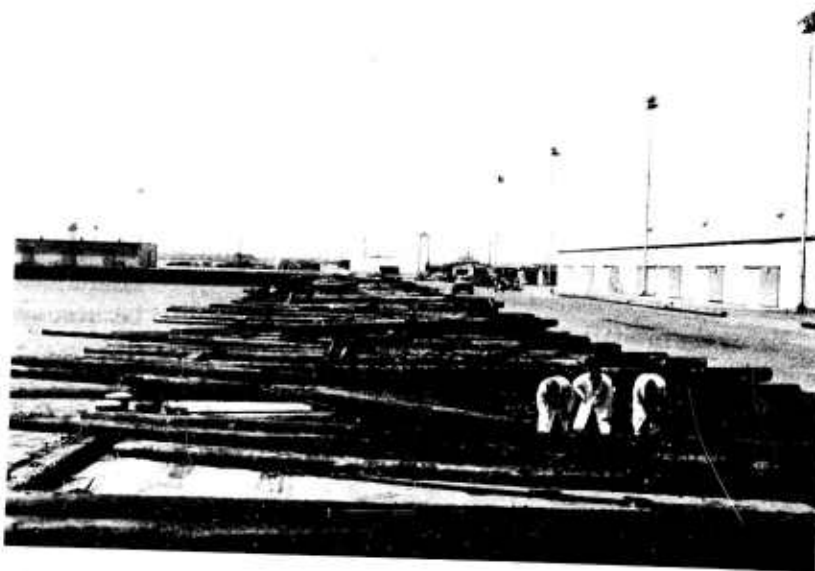
Figure 2. Inspection team examining piling removed from the harbor.

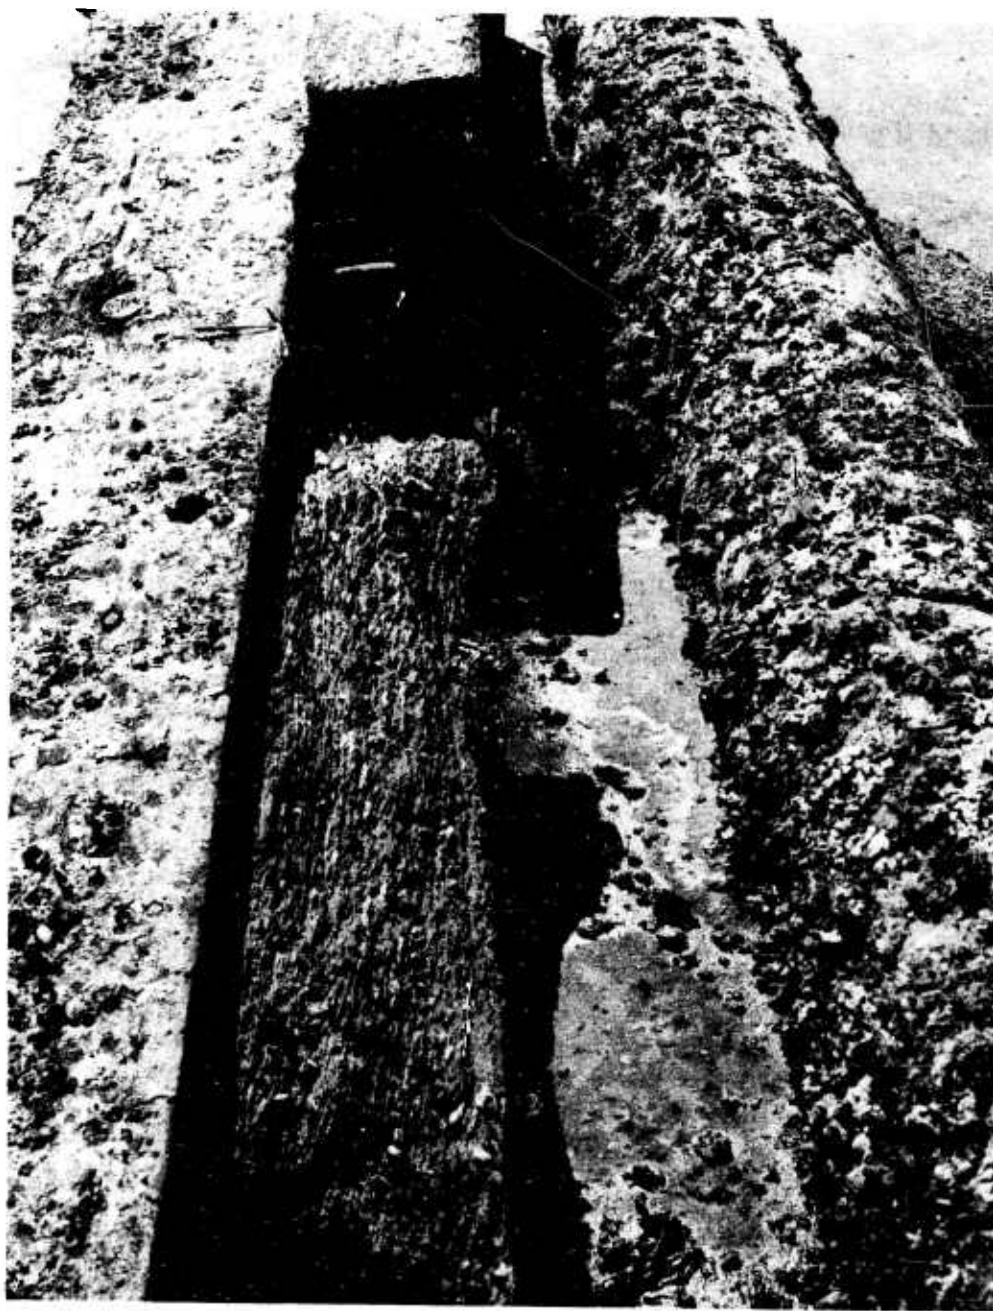
Figure 3. Creosoted whaling log which has succumbed to *Limnoria* attack.

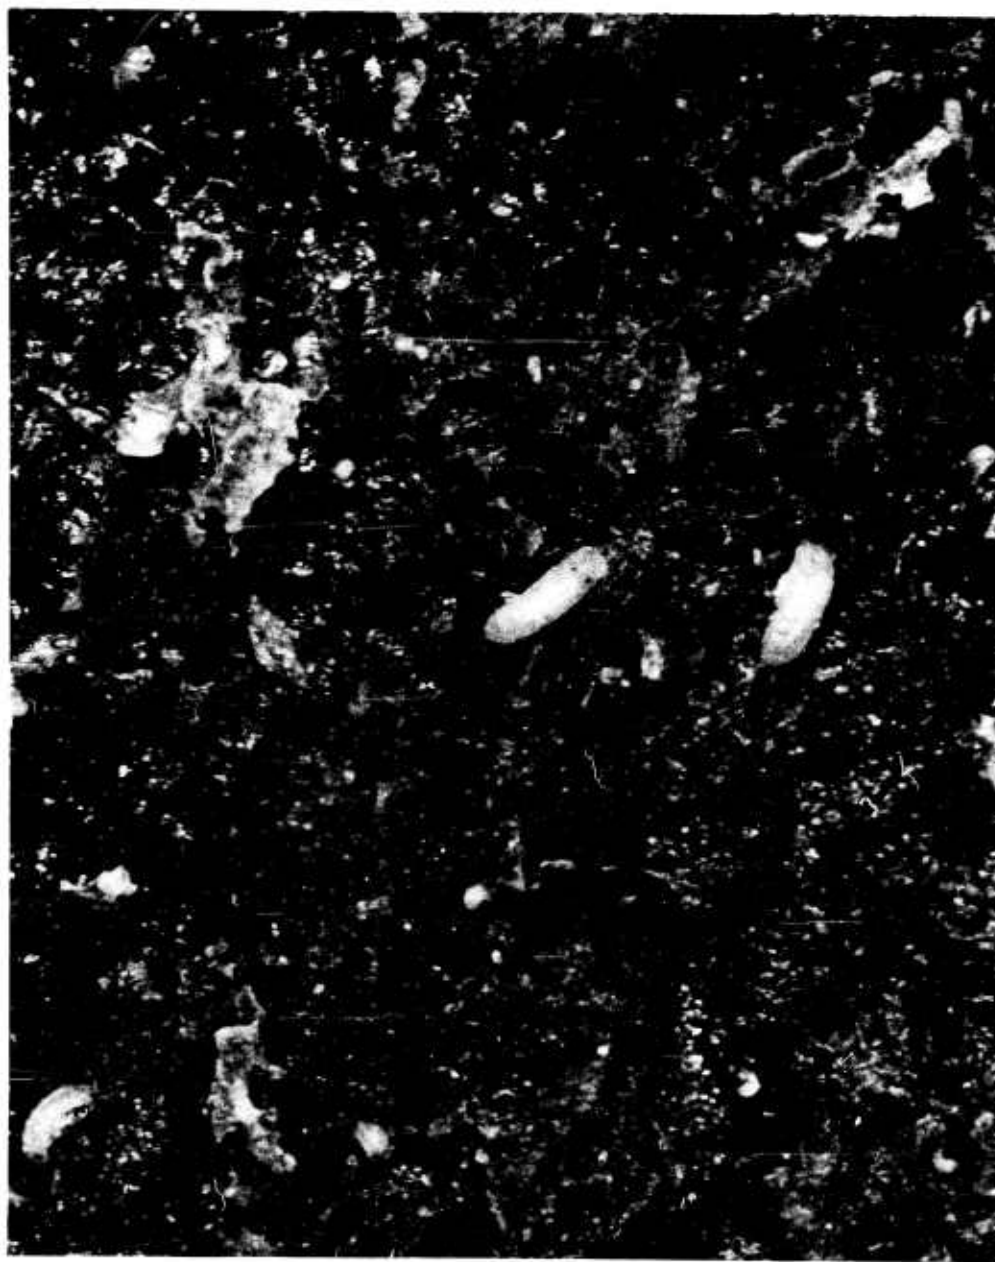
Figure 4. *Linnoria* crawling and burrowing on the surface of creosoted piling.

The attack was not confined to bolt holes, broken spots on the pile, and the like, as is often claimed, but was also on the open, still heavily creosoted face of the piling. Figure 4 presents a close-up view of the surface of a pile and discloses heavy *Limnoria* attack of wood still oozing with creosote. The figure clearly shows *Limnoria* crawling on and burrowing into the creosoted wood. Chips removed from the surface and brought into the laboratory for further study contained sufficient creosote to fill the room with the distinctive creosote odor and to stain the fingers of those examining the chips.

There appeared to be much greater activity in the movement of the *Limnoria* from their burrows to the surface of the wood and back again into the burrows than had been previously noted for *Limnoria* attacking untreated wood. This behavior may be necessary for survival of *Limnoria* in the presence of creosote.

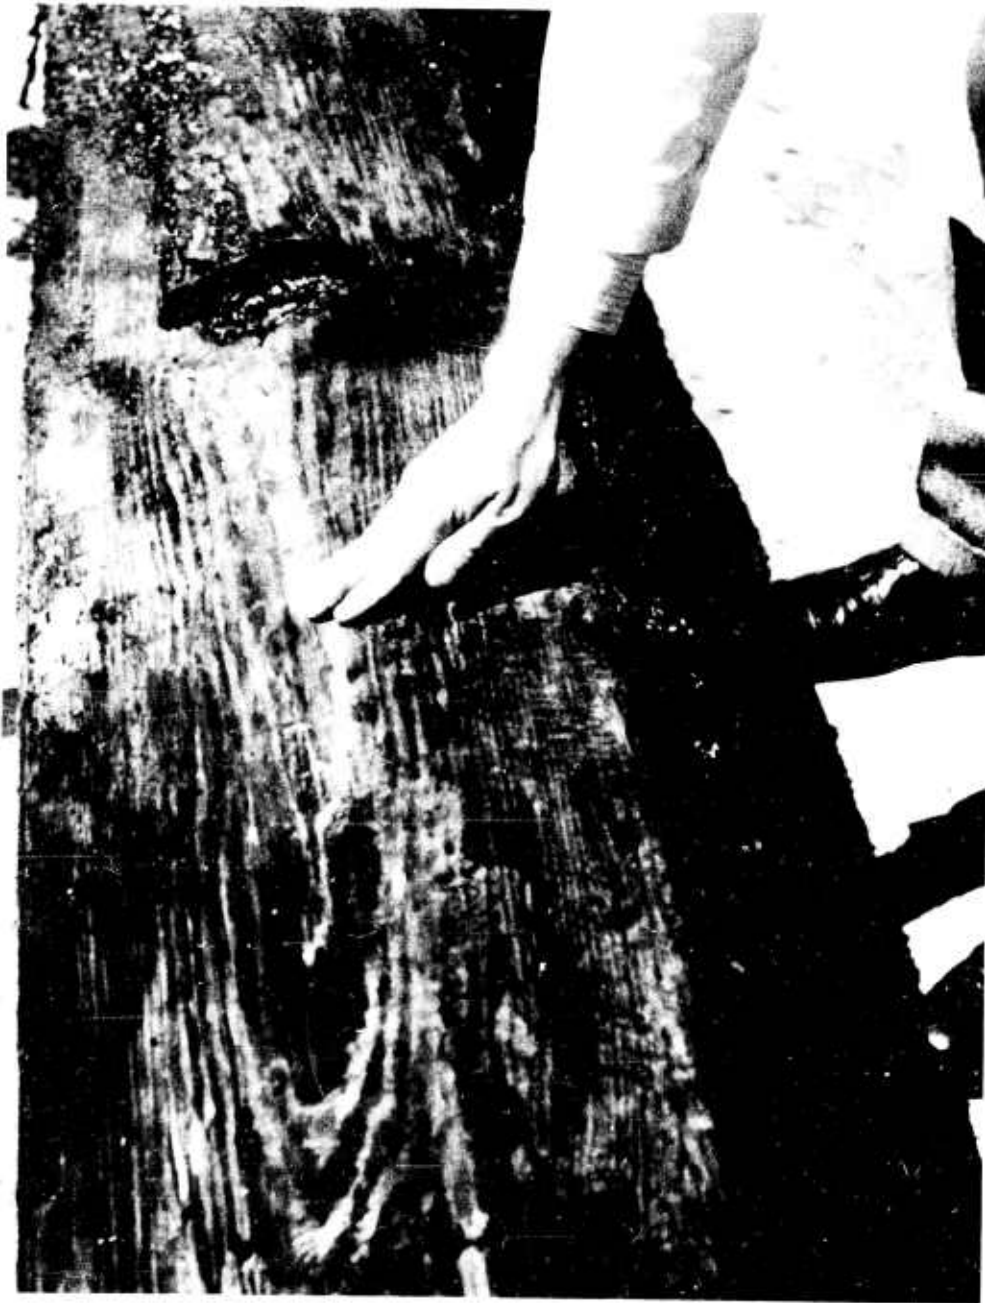
Figure 5. Surface of a pile worn smooth by the action of the "camel log."

At the intertidal zone the diameter of the piles is reduced both by the action of *Limnoria* and the action of the "camel logs" (fender logs floated in front of the dock to keep vessels from direct contact. The camel logs, which float on the surface of the water in front of the first tier of piles, rub back and forth against the surface of the piling with the action of each wave and each tide. This process wears a flat or smooth area on each pile in the intertidal zone. Erosion from this source is most extensive at the center of the intertidal zone and tapers off toward the upper and lower extremes of the intertidal zone. Figure 5 illustrates such an area. In most cases the camel logs had worn through the apparent depth of creosote penetration. However, colorless compounds in the creosote may penetrate more deeply than would be judged by the black areas of the wood. Wood removed from those areas worn smooth by the action of the camel logs still retained a distinctive creosote odor. No indication of *Teredo* or *Bankia* attack was noted. *Limnoria* attack was also light on these surfaces. It is possible that the constant rubbing of the camel log against the piling served to mechanically kill most of those attempting to lodge on this surface. Opposite the surface worn smooth by the camel log was the area of the wood most heavily attacked by *Limnoria*. The combined action of these two processes was serving to restrict the diameter of the pile to produce an hourglass contour.

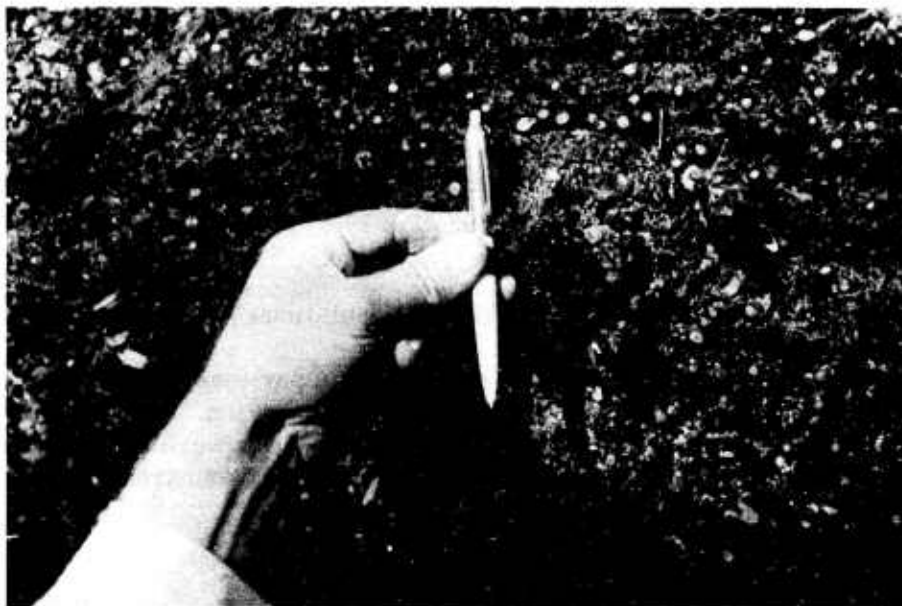
Examination of those areas covered by fouling organisms revealed very light attack. Figures 10 and 11 show the examination of the surface of a piling under one of the fouling organisms. The fouling organism, a rock oyster, had given complete protection to the pile. The surface of the pile underneath the fouling organism appeared like new. Even in those regions covered only lightly by a thin coating of Bryozoa the attack was very light.

Figure 10. Examination of a rock oyster fouling the surface of a pile.

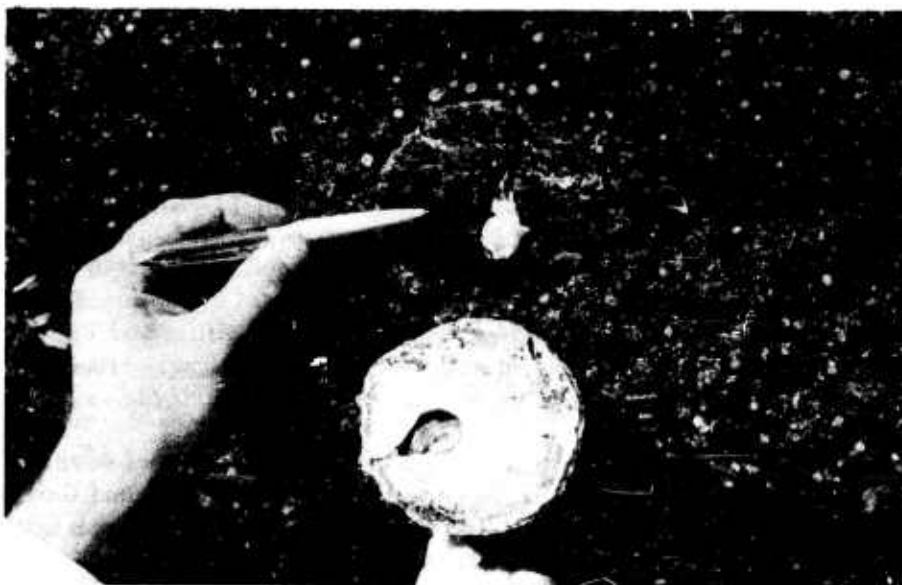
Figure 11. Examination of that portion of the surface of a pile which had been protected by a rock oyster.

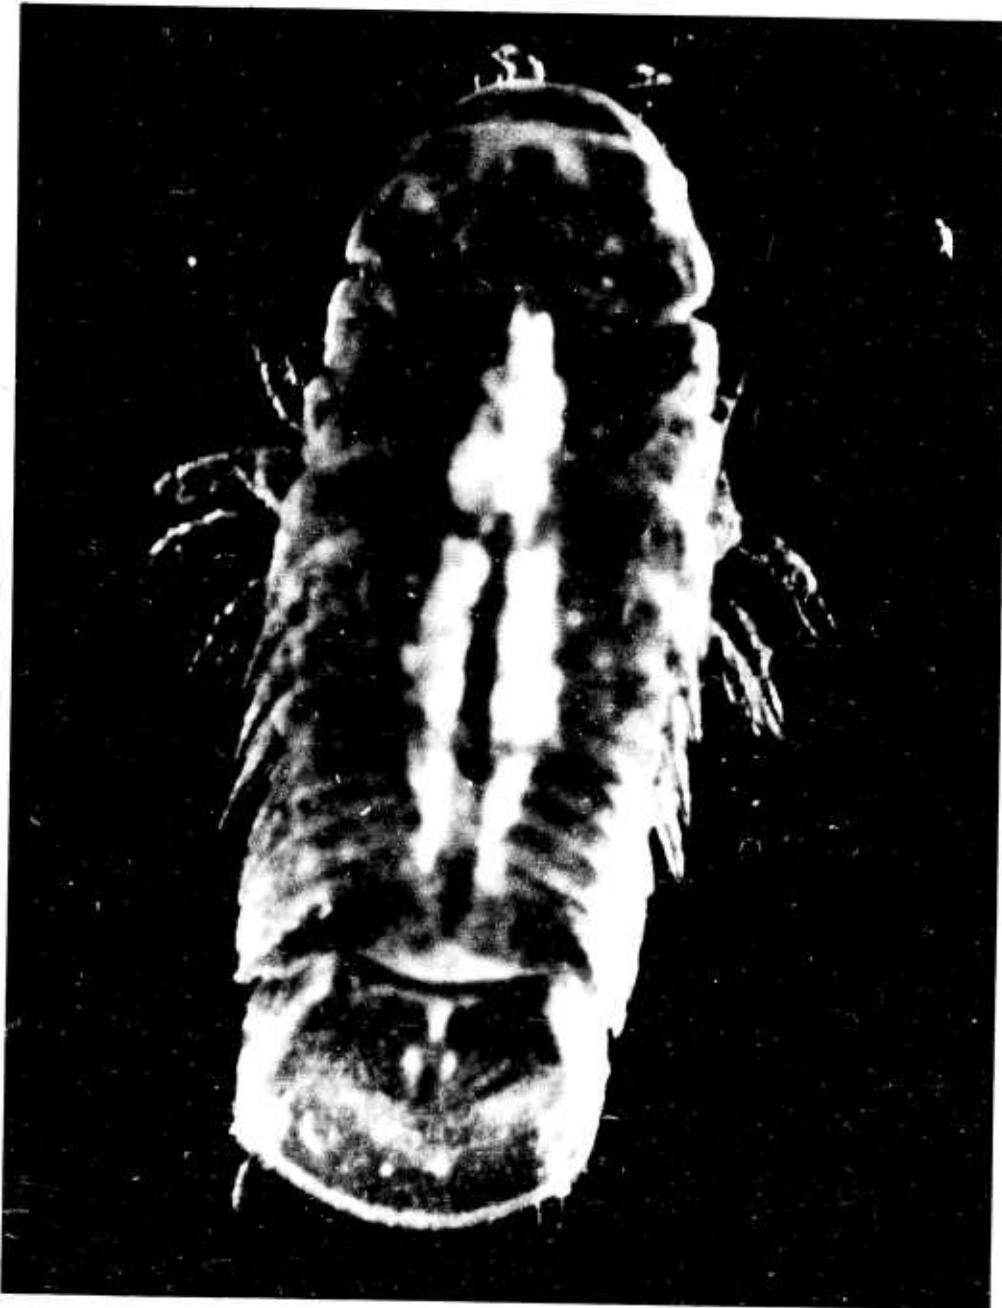
Preliminary examination revealed that for practical purposes the wood harbored only the species *Limnoria tripunctata*. Chips removed from heavily attacked regions of the wood also harbored appreciable numbers of an unidentified species of *Chelura*. Figure 12 illustrates the *Limnoria* removed from creosoted piling and Figure 13 the common species which collects on untreated piling. *Chelura* removed from creosoted piling are pictured in Figure 14.

Figure 12. Typical marine borer found on creosoted piling and identified as *Limnoria tripunctata*.

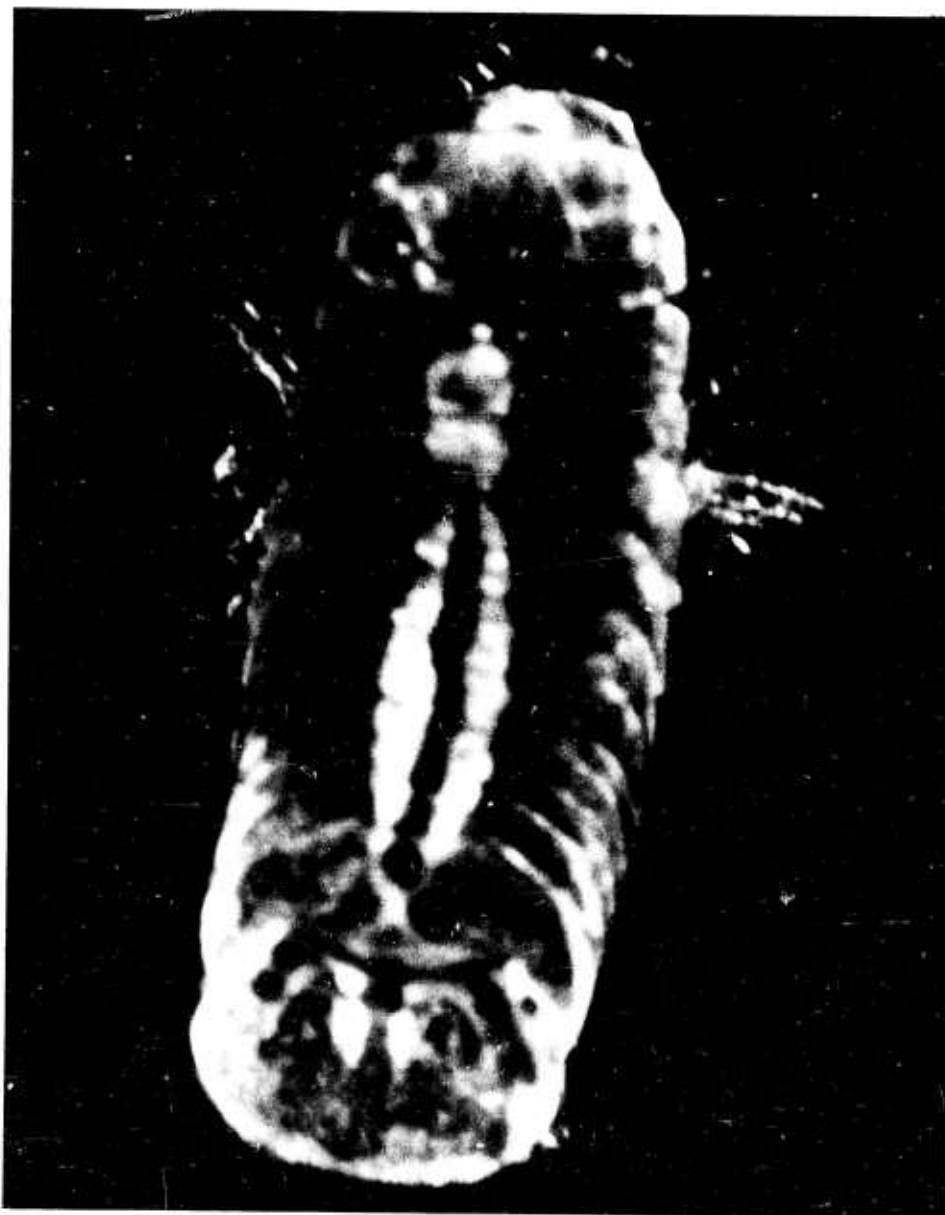
Figure 13. Common species of *Limnoria* found on untreated test blocks at Port Hueneme and identified as *Limnoria quadripunctata*.

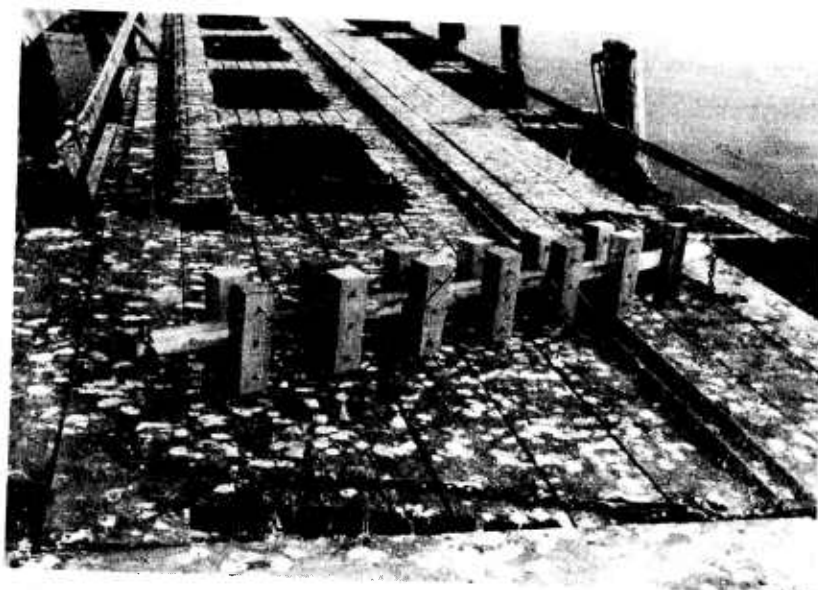
In order to obtain animals for toxicity studies at NAVCERELAB, laminated blocks of pine or fir measuring 4 in. by 4 in. by 12 in. were bolted to channel iron racks and these racks were suspended horizontally in the harbor about two feet from the mud line. The test pier is located in the same harbor as that from which the creosoted piling had been obtained. After a period of several months the racks were pulled out of the waters and the test blocks removed and stored in tall narrow jars (pipette cleaning jars) of sea water. Figures 15 and 16 illustrate a rack of test blocks before and after an exposure of eight months in the harbor.

Figure 15. Rack of collecting blocks ready to be placed in the harbor.

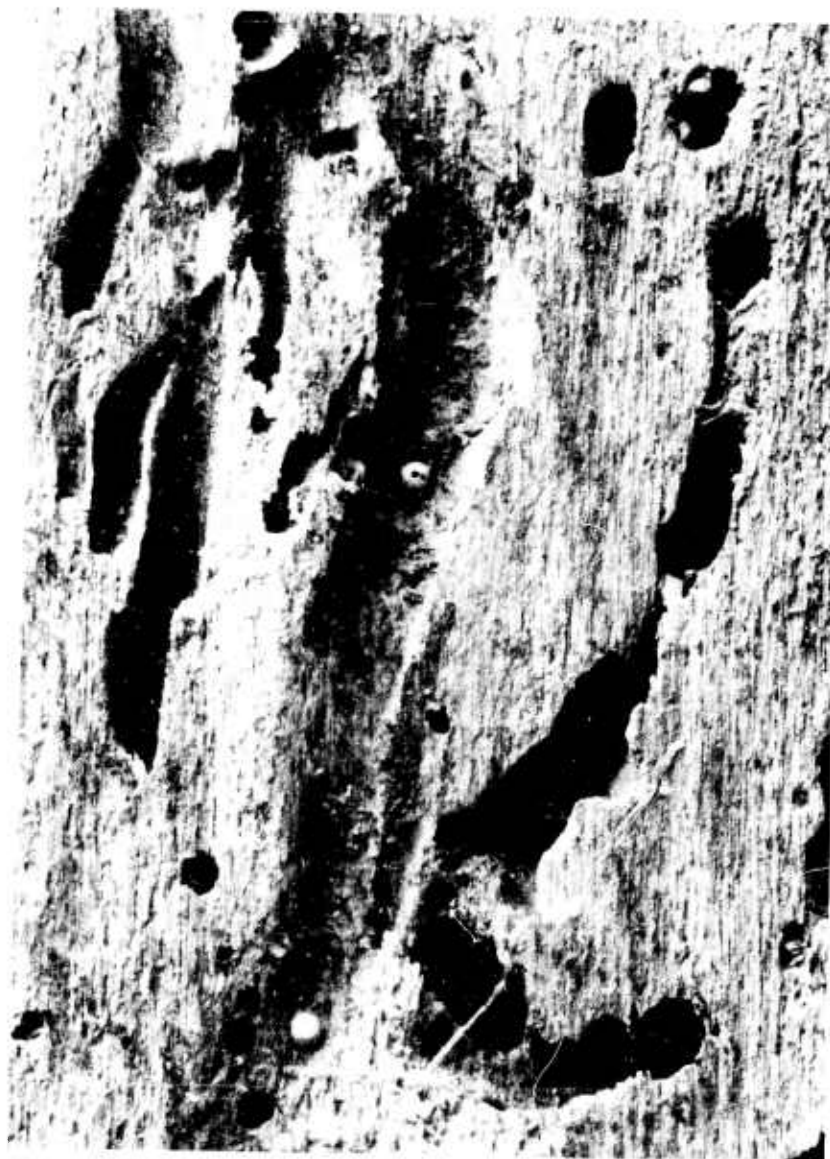
Figure 17 illustrates the extent of *Limnoria* damage to the surface of one of the laminated test blocks. Figure 18 presents a magnified view of the surface of the same block. The pitted surface clearly demonstrates that *Limnoria* were attacking the test block. Yet, the attack by such a sparse population of *Limnoria* as had developed in

Figure 18. Close-up view of the surface of an untreated test block lightly pitted from *Limnoria* attack.

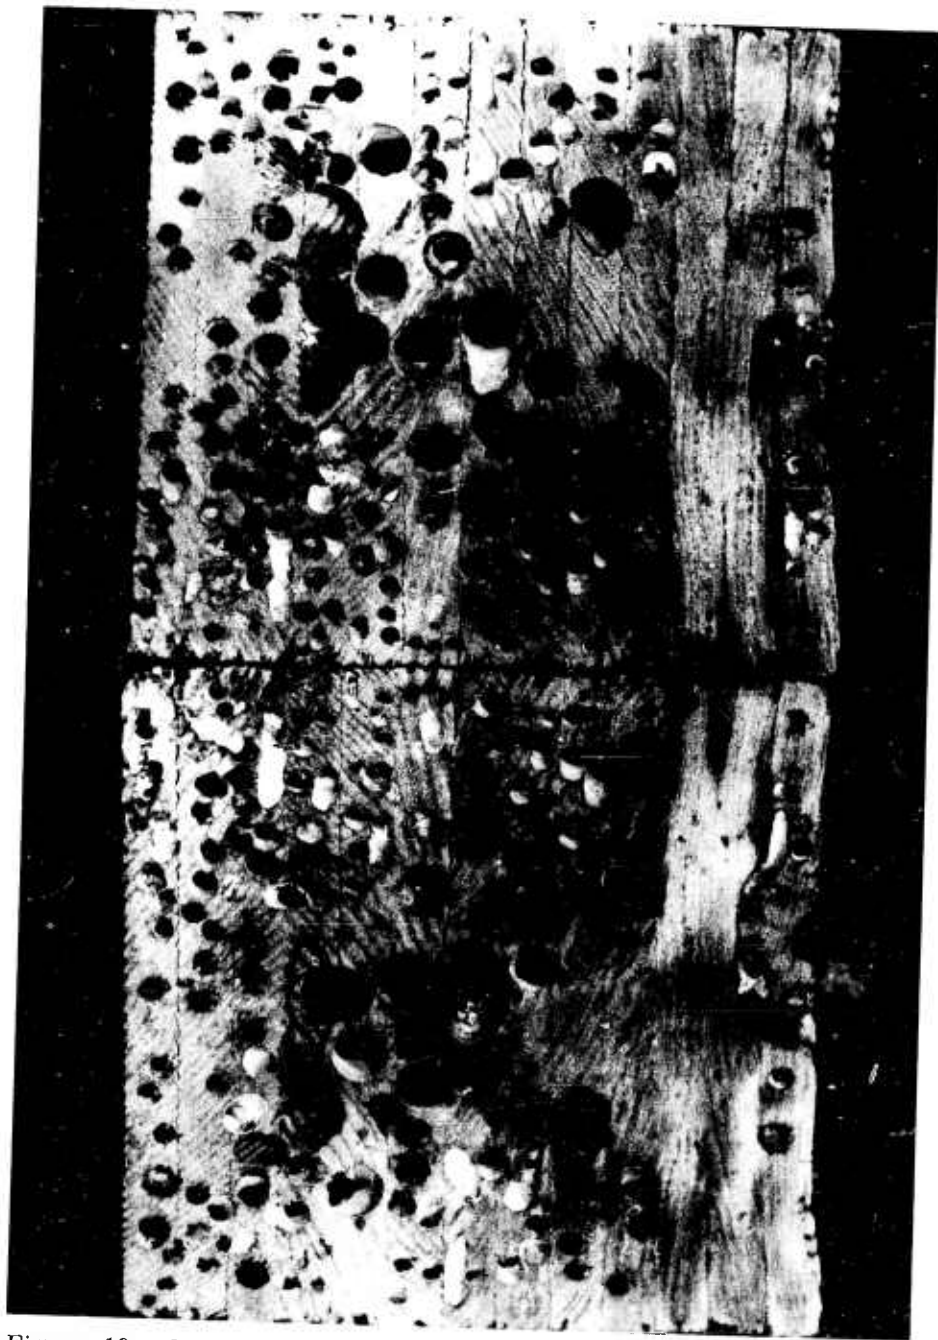
eight months' time was too light to cause extensive damage to the blocks. The extent of the *Teredo* and *Bankia* attack, however, which occurred in eight months was not light, as can be seen in a cross section of the same block illustrated in Figure 19. Infestation by these animals can occur quite suddenly.

Figure 19. Cross section of a collecting block which had been in the harbor for eight months.
